**DEPARTMENT OF TRANSPORTATION**

Contract #: 04-0120F4Cty: SF/ALA Rte: 80 PM: 13.2/13.9File #: 69.28**WELDING INSPECTION REPORT****Resident Engineer:** Siegenthaler, Peter**Address:** 333 Burma Road**City:** Oakland, CA 94607**Report No:** WIR-016562**Date Inspected:** 31-Aug-2010**Project Name:** SAS Superstructure**OSM Arrival Time:** 700**Prime Contractor:** American Bridge/Fluor Enterprises, a JV**OSM Departure Time:** 1900**Contractor:** Zhenhua Port Machinery Company, Ltd (ZPMC), Changxing Island **Location:** Shanghai, China**CWI Name:** Mr. Tian Lei**CWI Present:** Yes No**Inspected CWI report:** Yes No N/A**Rod Oven in Use:** Yes No N/A**Electrode to specification:** Yes No N/A**Weld Procedures Followed:** Yes No N/A**Qualified Welders:** Yes No N/A**Verified Joint Fit-up:** Yes No N/A**Approved Drawings:** Yes No N/A**Approved WPS:** Yes No N/A**Delayed / Cancelled:** Yes No N/A**Bridge No:** 34-0006**Component:** Orthotropic Box Girder (OBG)**Summary of Items Observed:**

## WELDING INSPECTION REPORT

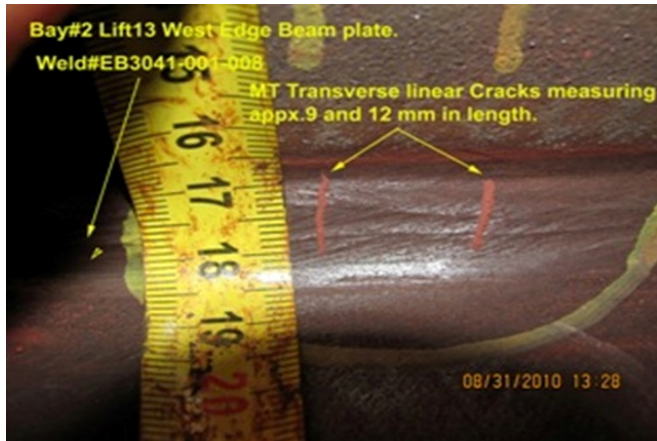
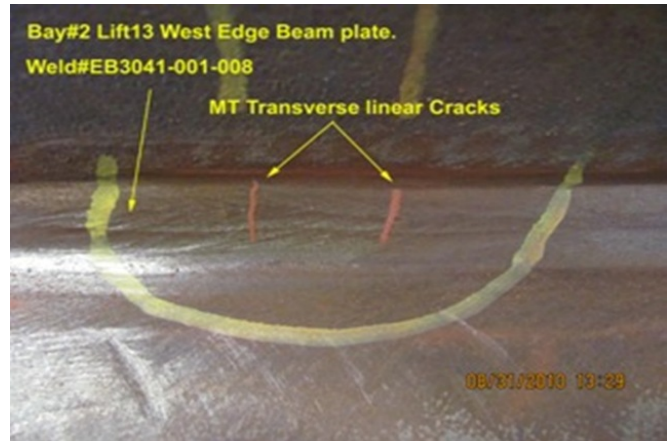
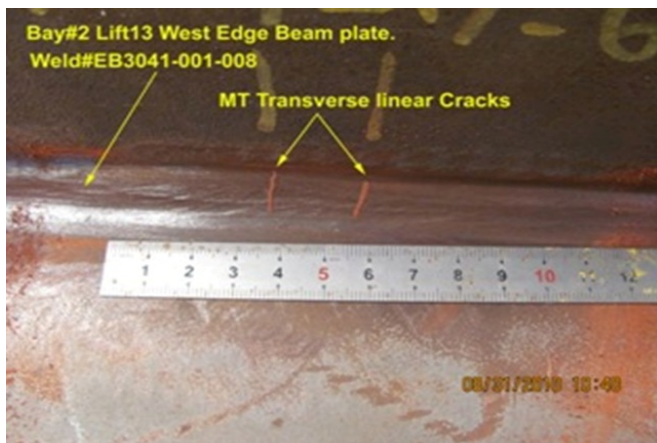
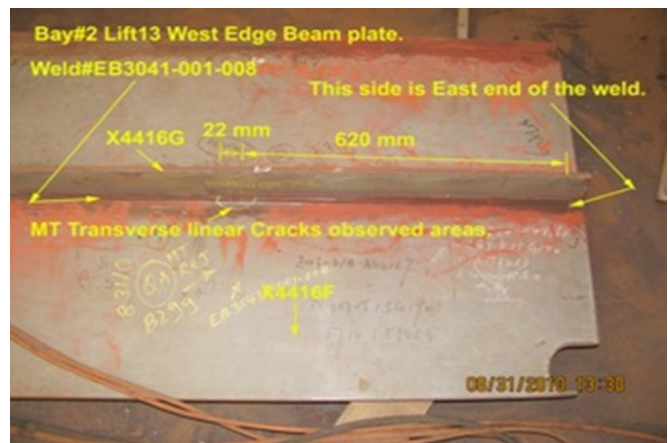
During QA MT review of welds located on OBG 13 West Edge Beam (EB) EB3041B, this QA observed Two (2) Transverse Linear Cracks measuring approximately 9 and 12 mm in length. The weld is identified as: EB3041-001-008. This weld is a fillet weld joining EB plate (X4416F) to Stiffener plate (X4416G). The “Y” locations are approximately 620 and 642 mm from the east end of the weld.

This QA Inspector generated an incident report on this date for the above issue, for further information see the incident report and the attached photos.
